# If you have black alkathene pipework, what can you do about it?

**Black Alkathene pipes are a type of plastic pipe which was developed in the 1930s and used in houses from the 1960s. It is no longer in use having been replaced by blue MDPE plastic pipe.**

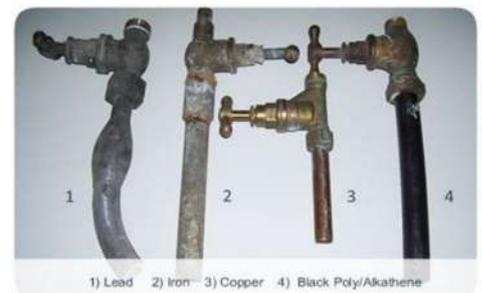
Black Alkathene pipework will usually be visible at the internal stopcock in the property, often under the kitchen sink. We recommend replacing Black Alkathene pipework as these issues might get worse as the pipe breaks down. .
